# Home Inspection Report

Billy Cales / Attentive Home Inspection

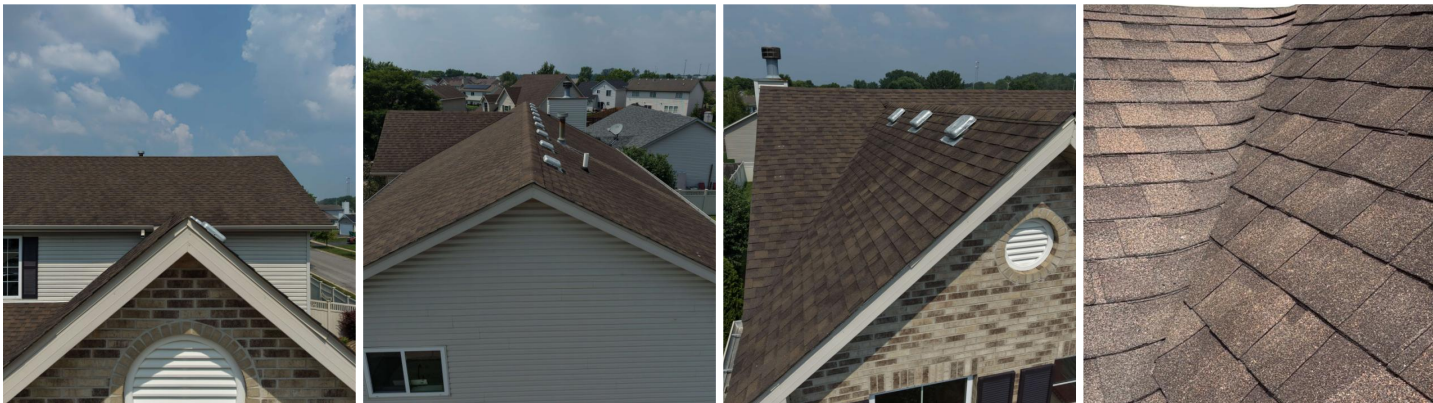
Aged Asphalt Shingle Roof Covering

The roof covering consists of asphalt composition shingles. Visible portions showed general aging and wear, including discoloration and granule loss. Granule loss reduces the shingles' protection from ultraviolet exposure and weathering and may indicate that the roof covering is approaching the end of its useful service life.

Recommend evaluation by a qualified roofing contractor to identify any needed repairs and determine whether replacement is warranted. Monitor the roof for leakage, loose or damaged shingles, and continued granule loss. Budgeting for future roof replacement is advised.

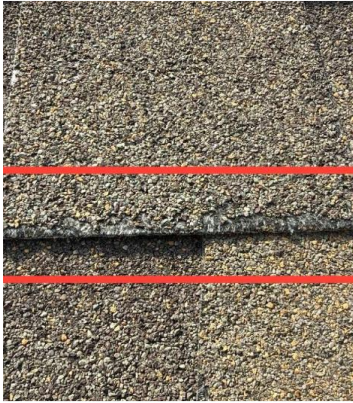
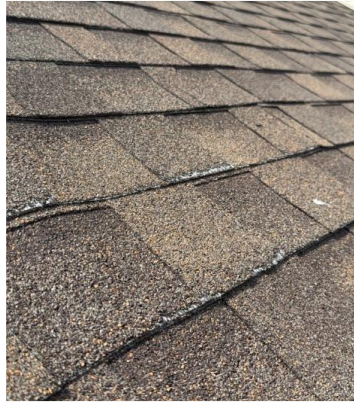
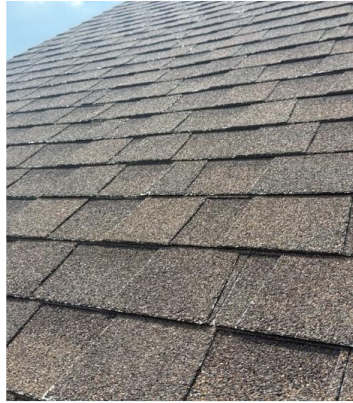
Significant granule loss  
around edges of shingles

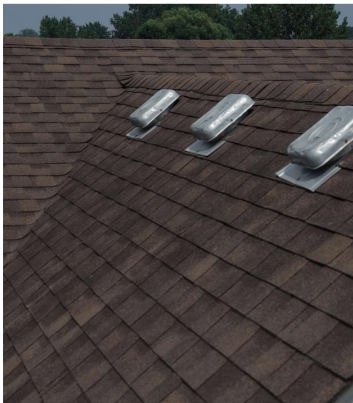
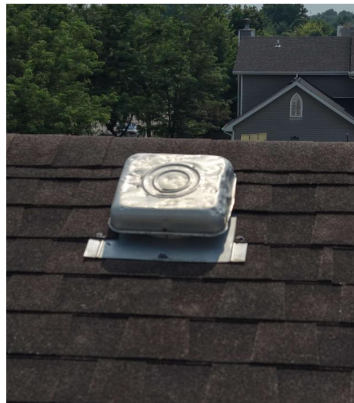
Damaged mushroom  
vent cap

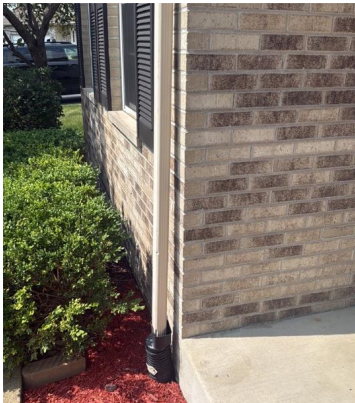
Location - Front of House

The downspout was loose and missing a support strap, and it should be properly secured by a qualified contractor to prevent damage or displacement.

Missing strap

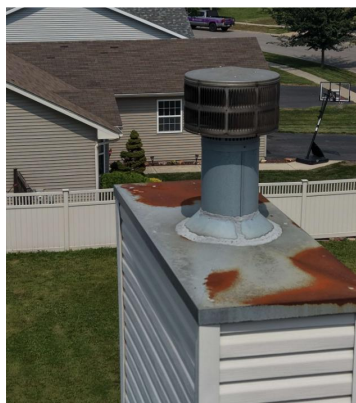
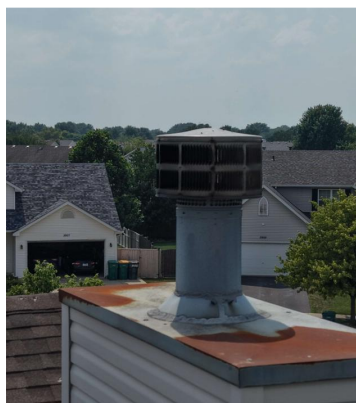
**Rusted Chimney Cap and Chase Cover**

The metal chimney cap and chase cover showed visible rust/corrosion and rust staining.

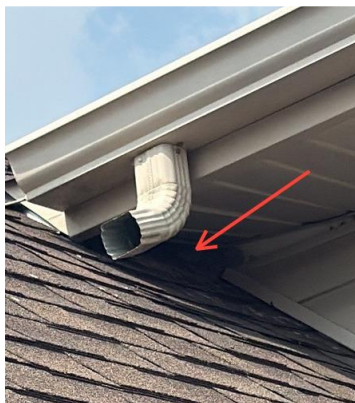
Missing Piece of Soffit

A portion of the soffit is missing, with bird droppings observed on the shingles and a possible bird nest in the soffit vent; recommend evaluation and repair by a qualified contractor and safe removal/cleaning by a pest or wildlife professional as needed.

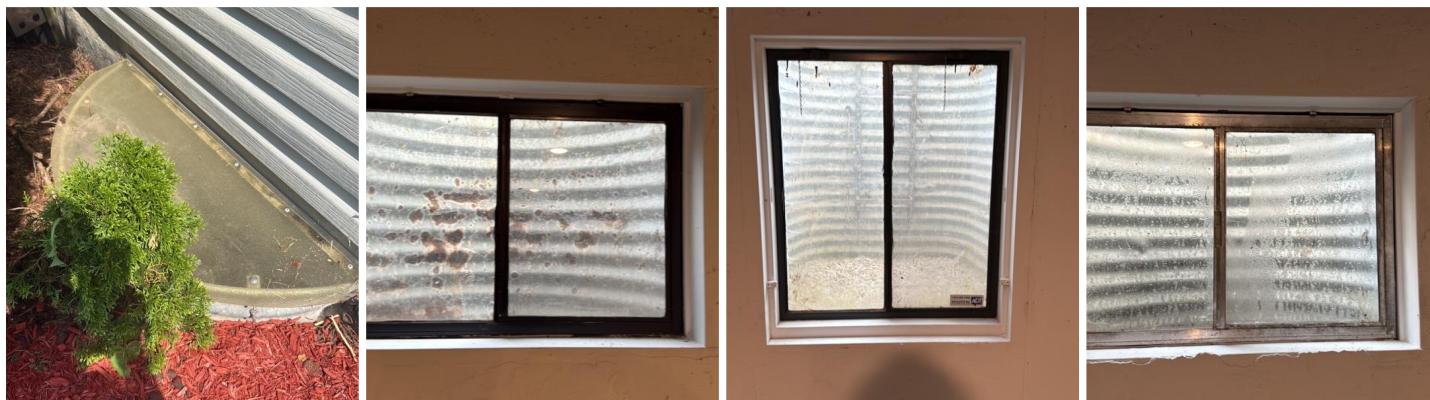
The basement windows were not operable, and the exterior window-well covers appeared to be mechanically secured. If these windows are intended or required to provide emergency escape and rescue access, the condition may prevent emergency egress. Recommend evaluation by the local building authority or a qualified contractor and modification as necessary to provide safe, readily operable emergency escape access.

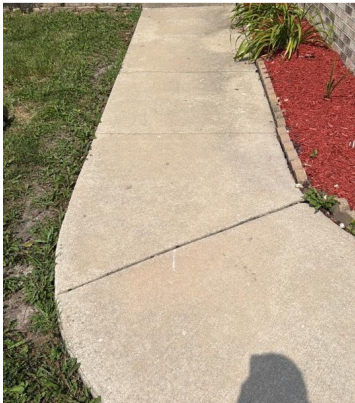
Concrete Patio Settlement and Trip Hazard

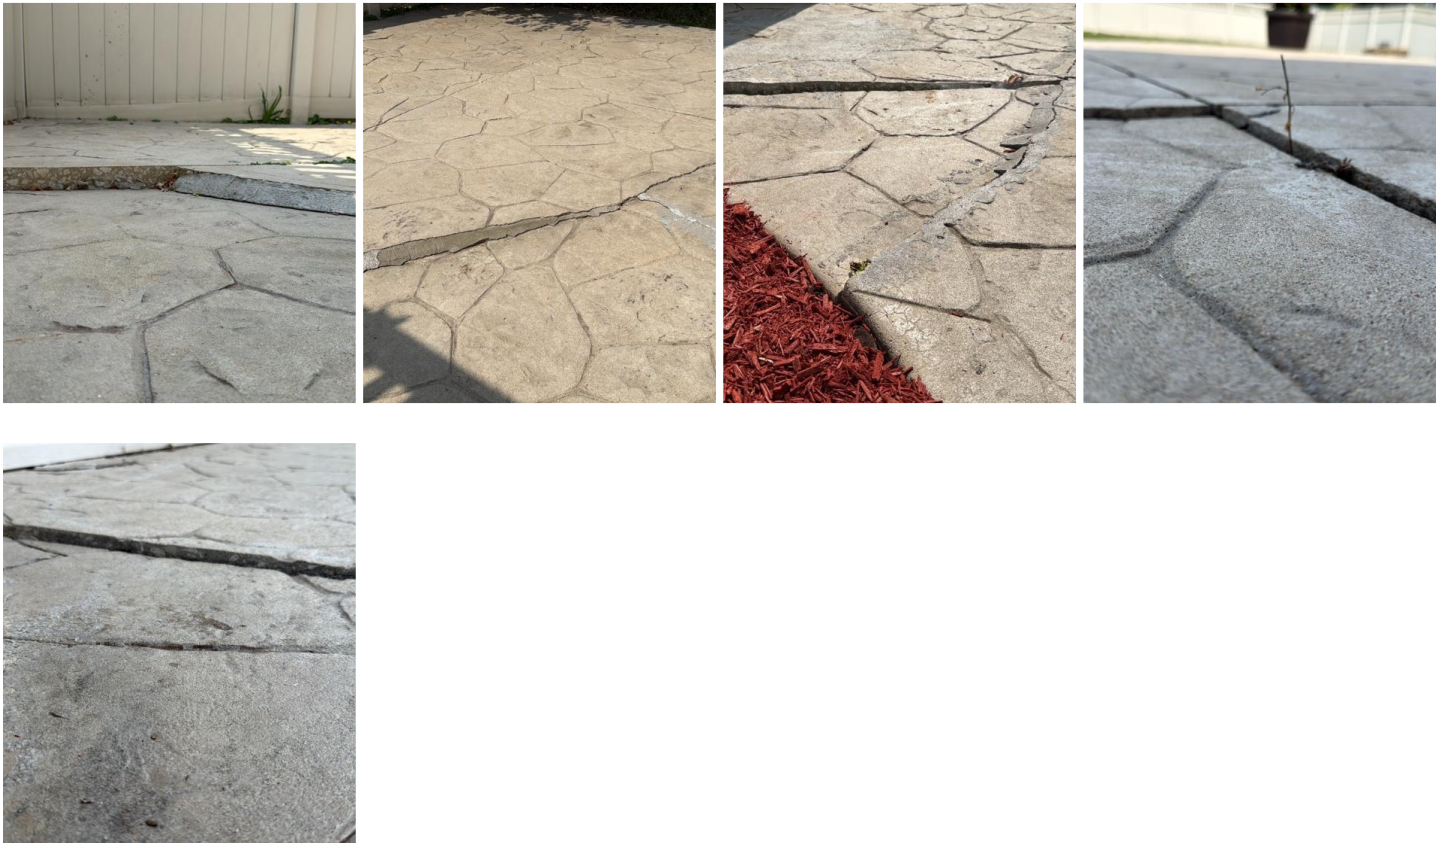
Location - Rear Patio

Significant settlement and displacement was observed at the concrete patio, creating a trip hazard; recommend evaluation and repair or replacement by a qualified concrete contractor.

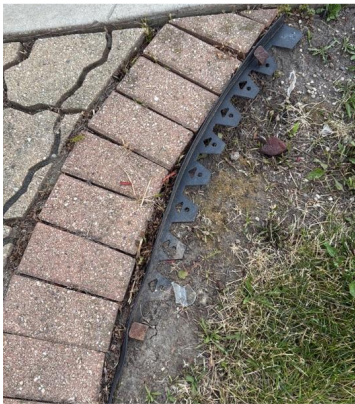
Damaged/Exposed Walkway Edging

Numerous areas of the paver walkway had displaced or damaged edging, adjacent soil erosion, and uneven pavers. Recommend repairing or replacing the edging and prop-

erly backfilling and compacting the affected areas to stabilize the walkway and reduce potential trip hazards.

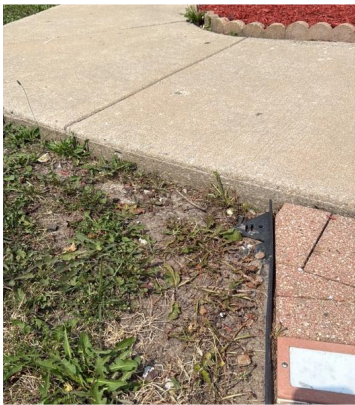
Soil Erosion at Walkway Edge

Numerous areas of soil erosion were observed along the edge of the concrete sidewalk, and correction by backfilling, compacting, and maintaining proper grading is recommended to reduce trip hazards and help prevent undermining of the walkway.

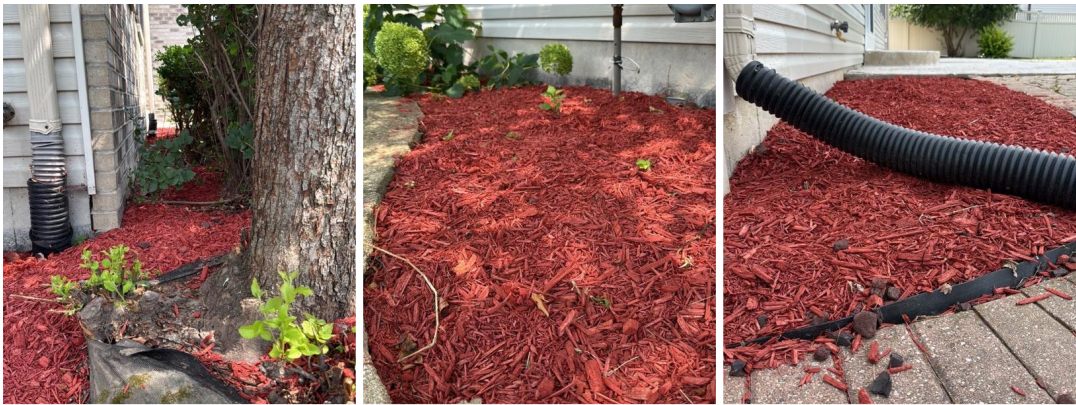
Improper slope. Pitch grading so that the water drains away from the house.

Negative to zero slope

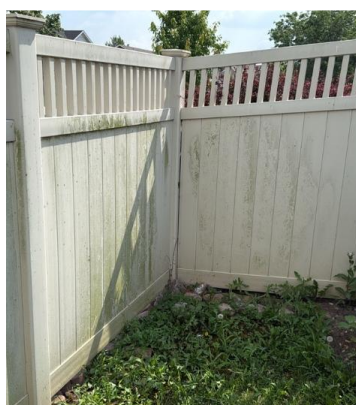
#### Algae Staining on Fence

Algae staining was observed on the fence; recommend cleaning and treating the affected areas as needed and maintaining proper clearance/airflow to help prevent recurrence.

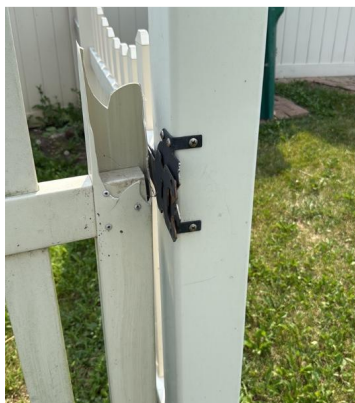
#### Damaged Fence Gate Hardware

Damaged fence gate hardware was observed, and repair or replacement by a qualified contractor is recommended to restore proper operation and security.

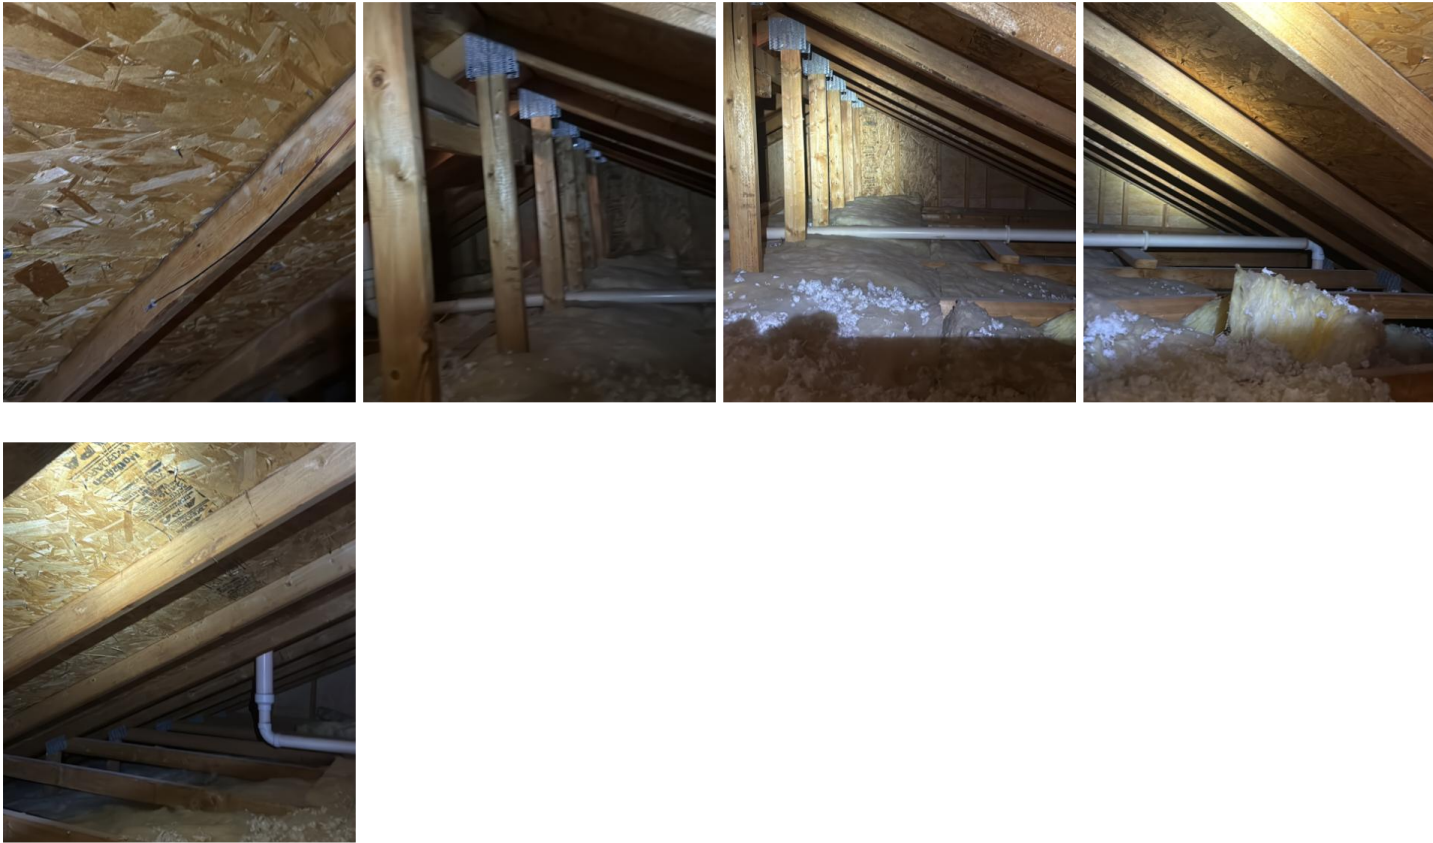
The attic appeared dry at the time of inspection, and no visible water staining was observed in accessible areas. Due to the age and condition of the roof covering, periodically monitor the attic for signs of water intrusion and address any leakage promptly.

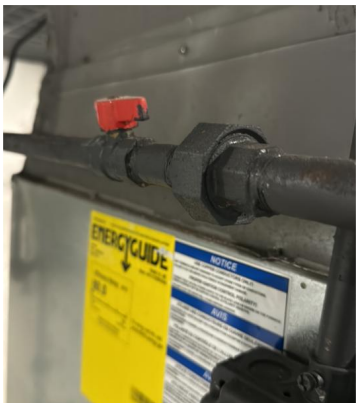
Furnace gas shutoff

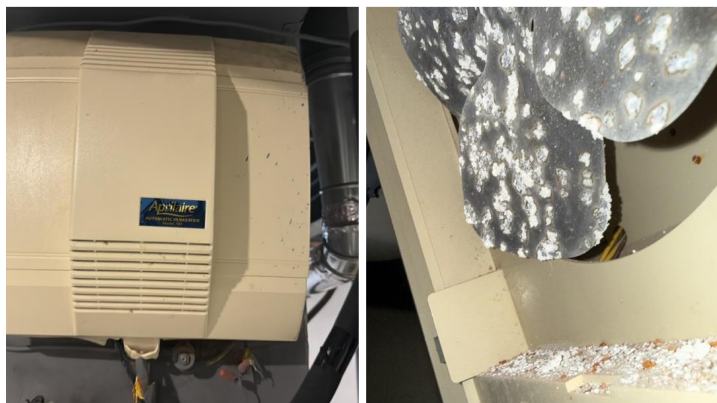
Humidifier Air Leakage and Mineral Buildup

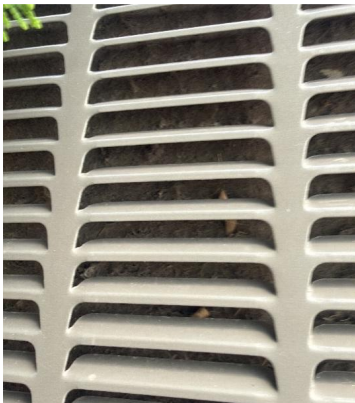
Vegetation Obstructing Condenser

Vegetation was obstructing the condenser unit, which can restrict airflow and reduce system efficiency, and it should be trimmed back to provide proper clearance around the unit.

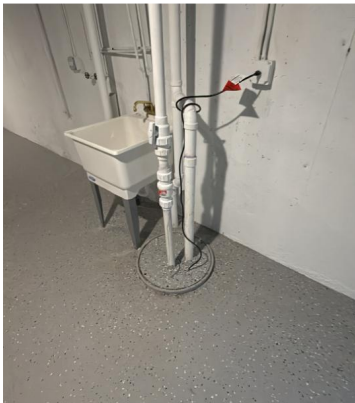
Ejector Pit

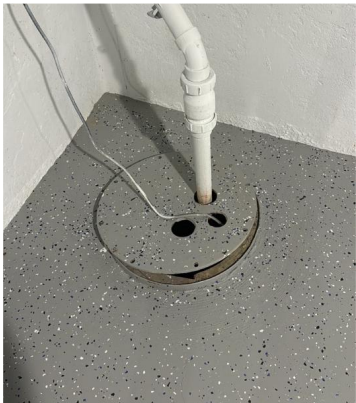
Sump Pump

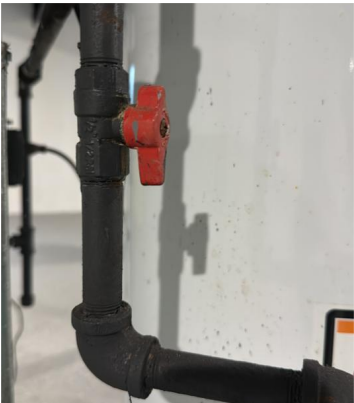
Gas shutoff

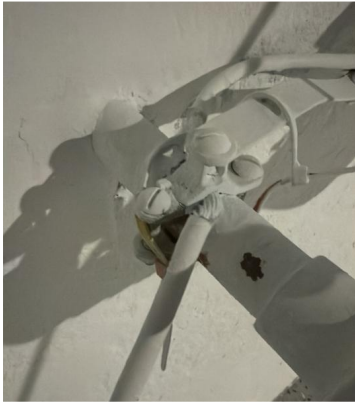
Painted Electrical Grounding Connection

The electrical grounding connection at the metal water piping was painted. Paint may prevent proper metal-to-metal contact and can compromise the reliability of the grounding or bonding connection. Recommend evaluation and correction by a licensed electrician, including removal of paint at the clamp contact area and verification that the grounding connection is secure and effective.

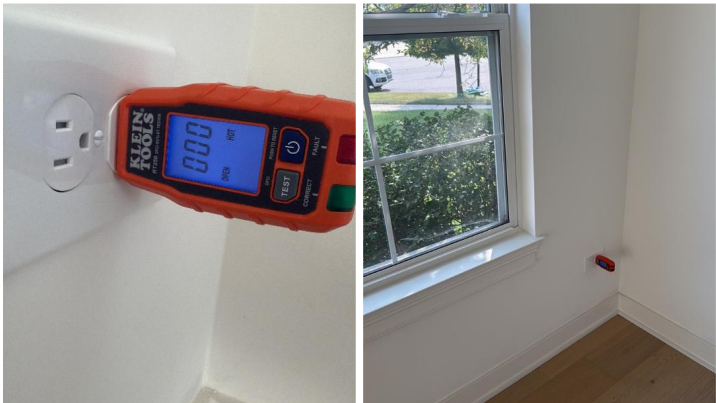
Location - Living room

The tested receptacle registered 0.0 volts and was not energized at the time of inspection, indicating an inactive branch circuit/receptacle condition.

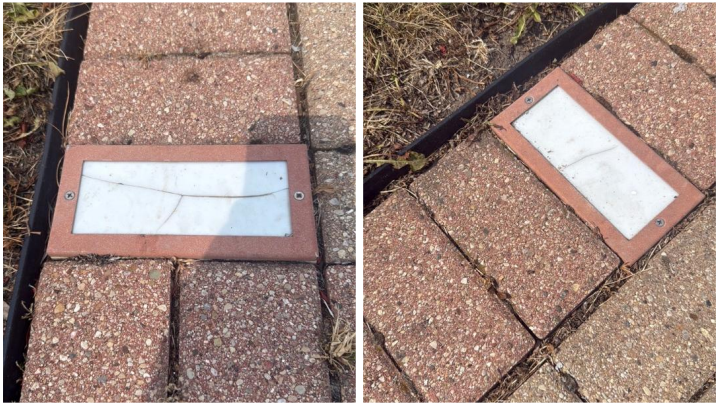
Location - Along Driveway

Cracked Exterior Light Cover

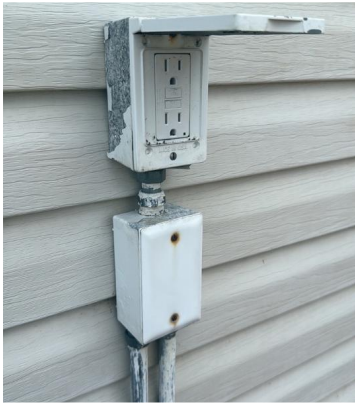
Location - Rear Patio

The outdoor GFCI receptacle was inoperable at the time of inspection, and a qualified electrician should evaluate and repair it as needed.

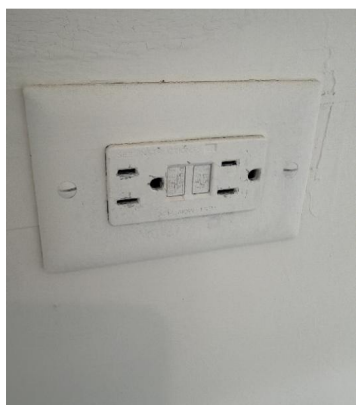
Location - Garage

The garage GFCI receptacle and/or its test and reset controls were painted. Paint can interfere with proper operation, conceal damage, and prevent reliable testing or resetting. Recommend replacement of the affected receptacle by a licensed electrician.

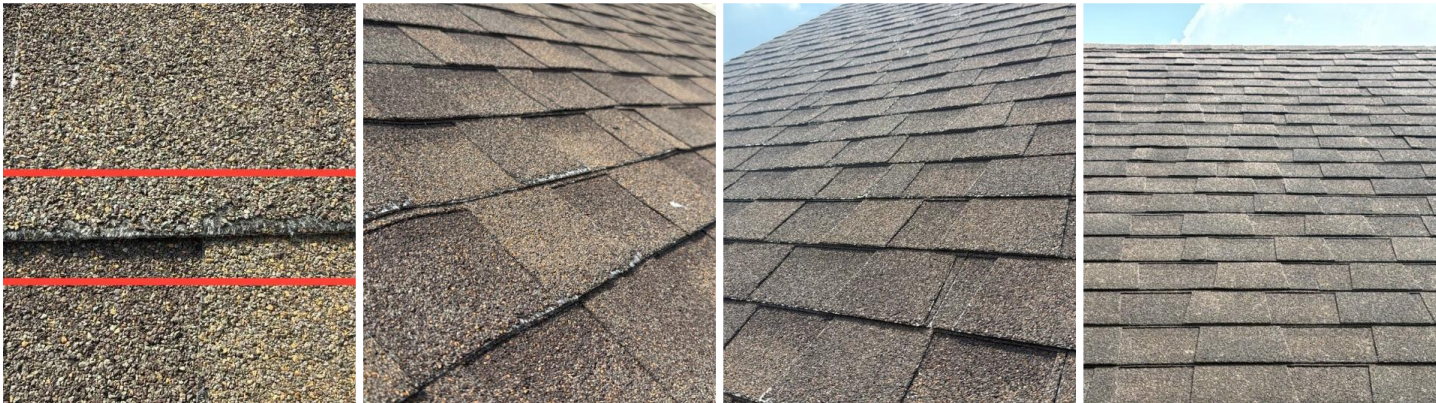
The roof covering consists of asphalt composition shingles. Visible portions showed general aging and wear, including discoloration and granule loss. Granule loss reduces the shingles' protection from ultraviolet exposure and weathering and may indicate that the roof covering is approaching the end of its useful service life. Recommend evaluation by a qualified roofing contractor to identify any needed repairs and determine whether replacement is warranted. Monitor the roof for leakage, loose or damaged shingles, and continued granule loss. Budgeting for future roof replacement is advised.

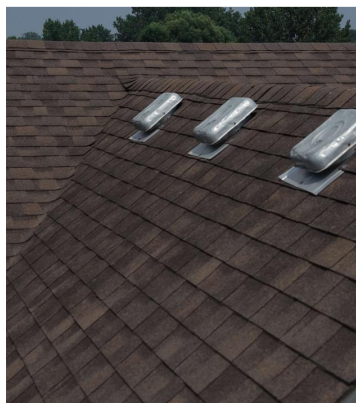
Significant granule loss around edges of shingles

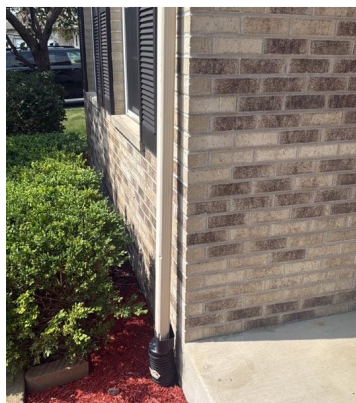
Location - Front of House

Missing strap

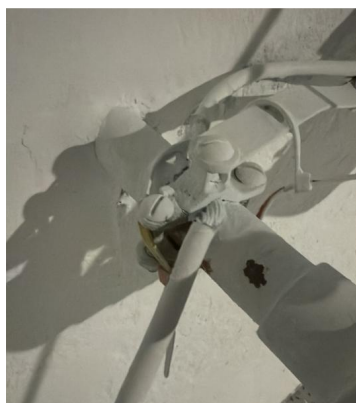
##### Painted Electrical Grounding Connection

The electrical grounding connection at the metal water piping was painted. Paint may prevent proper metal-to-metal contact and can compromise the reliability of the grounding or bonding connection. Recommend evaluation and correction by a licensed electrician, including removal of paint at the clamp contact area and verification that the grounding connection is secure and effective.
